5.5 Reach 3

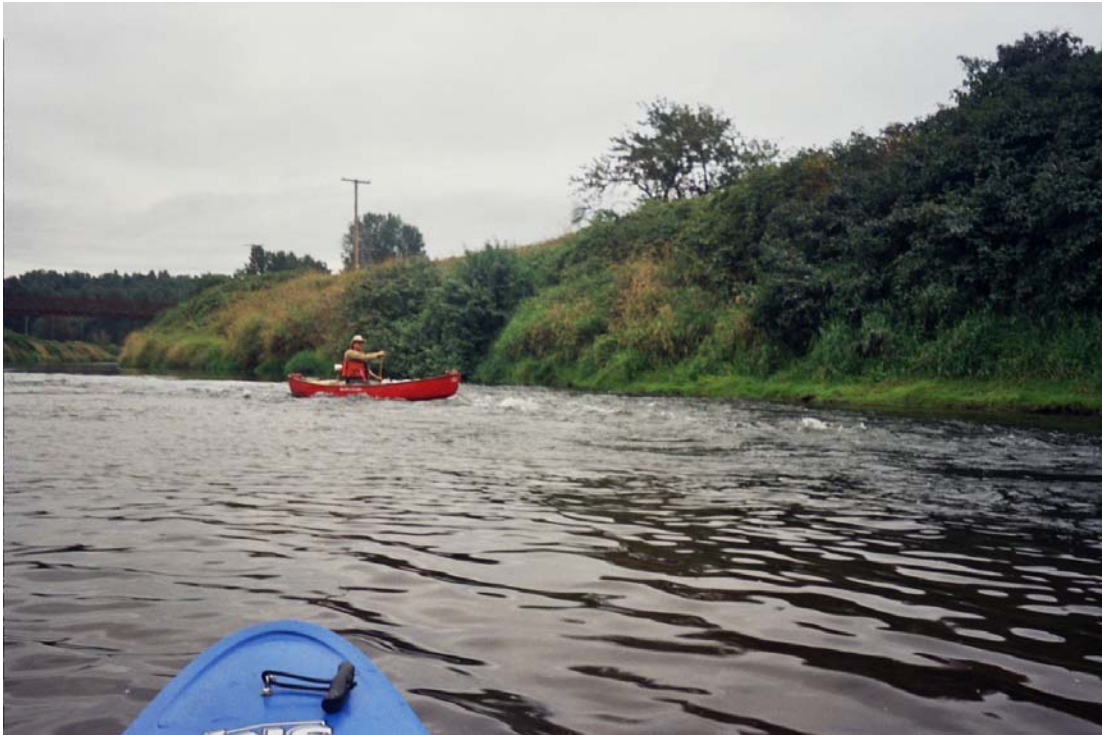
Photo 5-10. Invasive vegetation and high banks typical of Reach 3, Station 5.

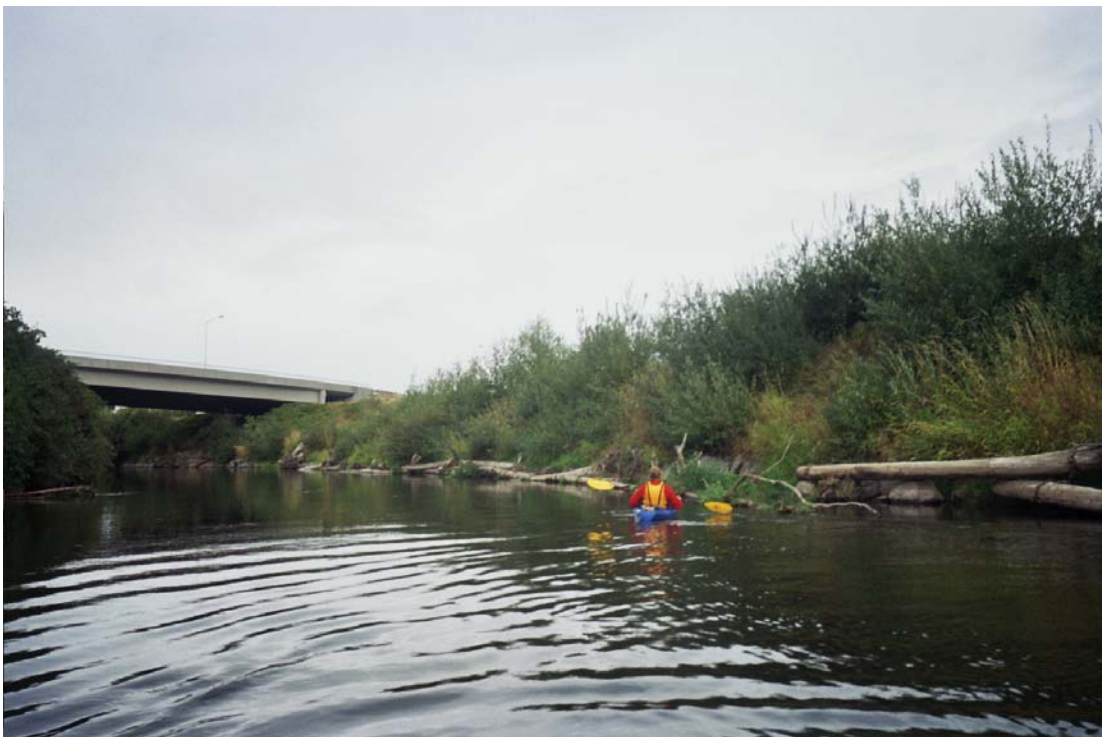
Photo 5-11. The 212th Street bridge crossing at Reach 3, Station 36 of the Lower Green River. The King County Rivers project on the right bank is typical of many other projects in the reach.

Surveys of Reach 3 (RM 19.1 – 15.6) were completed on September 18 and 19, 2003. Reach 3 is generally distinguished from the other reaches by a prominent set of clay layers in the strata underlying the floodplain. Upstream of where the river cuts through these clay layers the channel depth is greatly reduced, whereas just downstream from the clay layer zone, channel depth increased dramatically. Bank erosion in this reach also appears to be naturally controlled by the presence of resistant clay layers. As is the case throughout the study area, riprap is highly visible on most of the outside bends in this reach. Vegetation is dominated by Himalayan blackberry and reed canarygrass (Photo 5-10). Woody debris is fairly common throughout this reach, but there are few opportunities for future wood recruitment because of a paucity of trees along the banks. Much of the wood in this reach appeared to have been transported into the reach from upstream because many of the pieces were broken or shattered portions of logs. Moreover, wood in this reach is generally smaller than the wood seen in the other reaches. Reach 3 contains the crossing at the 212th Street bridge (Photo 5-11).
